# Manhole Inspection Summary

Manhole # **S15C\_\_020MH**

Insp Date: **7/2/08 4:58 PM**

**Location** Address: **2650 FRANKLIN ST**

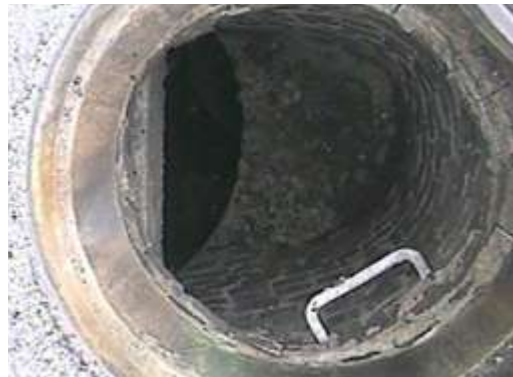
Defect 1

Offset: **1** (in.)

Condition: ☐ Sound ☒ **Cracked** ☐ Root Intrusion ☐ Loose Brick ☐ Deteriorated

Count: **2** Missing: **0** ☒ **Corroded**

offset frame, corroded steps and deteriorated chimney

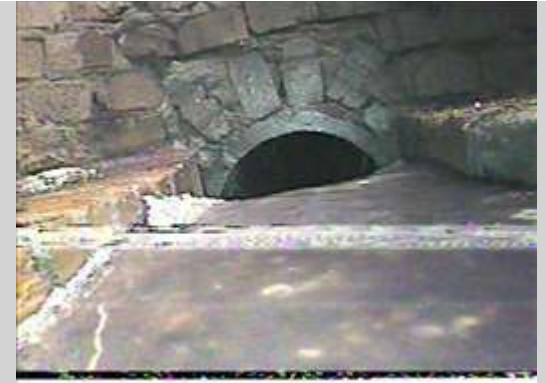
12 O'Clock Outflow

10 in. Circular Gravity Sewer  
Pipe Out @ 12 O'Clock

Deposits: ☐ None ☐ Mud ☐ Sludge ☒ **Debris** ☐ Grease

Silt Depth: **2** (in.) Deposits Extent: **Light**

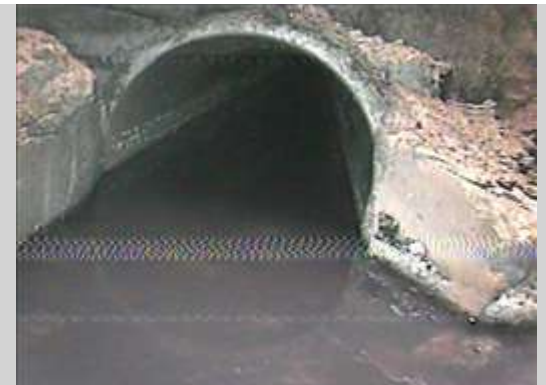
3 O'Clock Inflow

8 in. Circular Gravity Sewer  
Pipe In @ 3 O'Clock

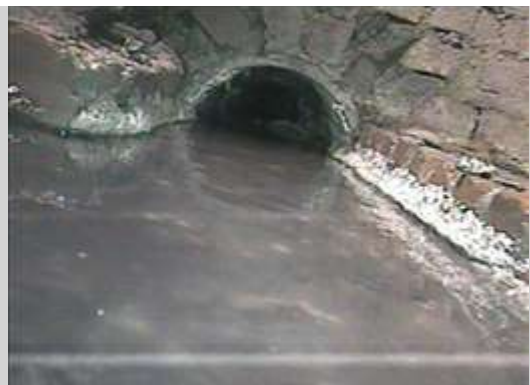
6 O'Clock Inflow

10 in. Circular Gravity Sewer  
Pipe In @ 6 O'Clock
